| ECTM Notification | Prepared by | Camilla Iversen | |

M Pos 2
PCE-FA

Trend data on file for the period between 17/06/2003 and 01/09/2007

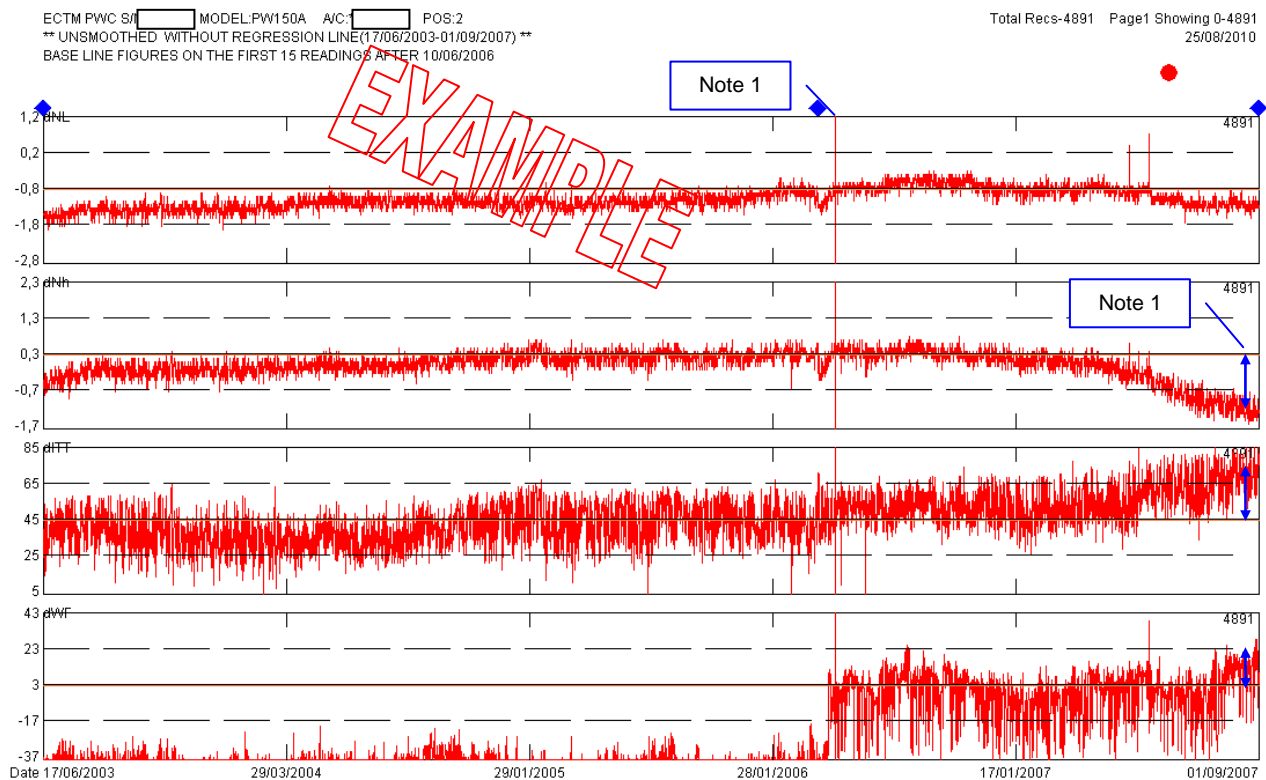
Note 1: Baselines recalculated by previous DAC/Operator, possibly because of work on the fuel flow indication system.

Note 2: NH decrease of 1,5%, ITT increase of 30°C and fuel flow increase of 15 pph. This trend looks like the clear indication of Hot Section deterioration in the HP section of the engine.

It's recommended to perform a power assurance check before next flight to verify the engine is producing sufficient power for safe operations.

As soon possible perform a borescope inspection and based on the findings determine if a hot section inspection should be performed.
