Danish Engine Trend Analyzing

ECTM[®] REPORT

2nd part 2015

Containing trend data until 19/04/2015
WebECTM Release No. 3.2.2 – Build 21

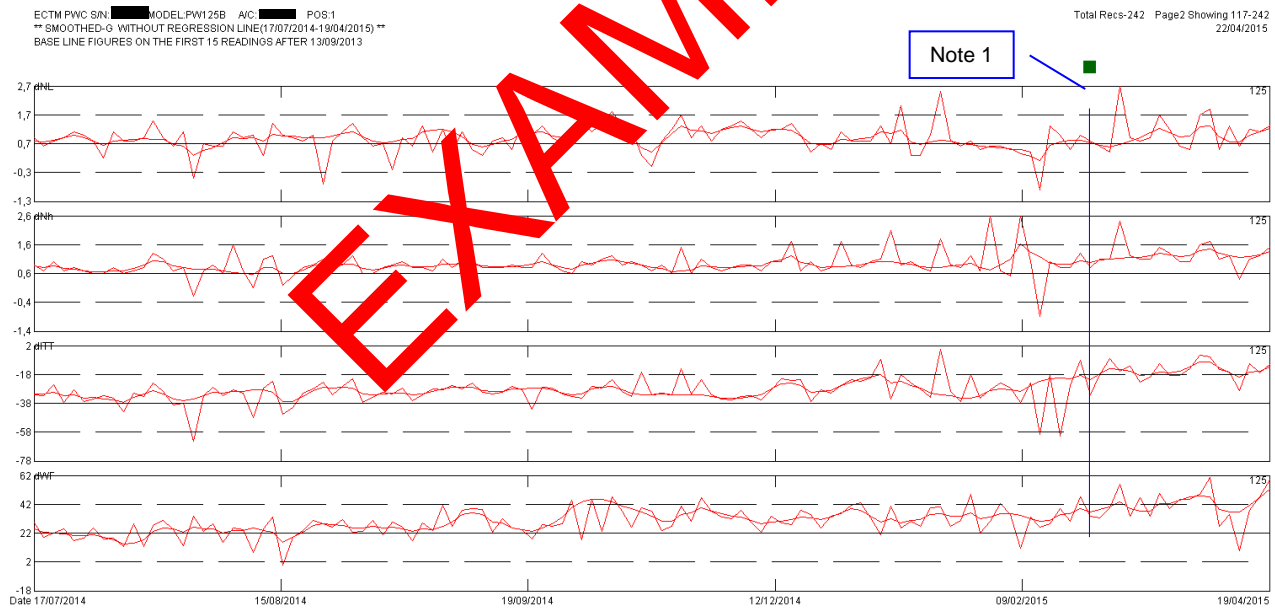
██████████ position 1
PCE-██████████:

Note 1: Around 09/03/2015 all graphs makes step changes increasing. At this point NL is slightly above the baseline, NH is 0,6% above the baseline, ITT is 22°C above the baseline and WF is 20 pounds above the baseline.
This looks like a cold section problem or bleed air leak, but could also be maintenance performed or an engine change that we were not informed about.

If no maintenance or engine changes were performed around the date described we recommend that the following troubleshooting is done:

- Perform a compressor recovery wash.
- Check the bleed air and air cond. valves for proper operation and closure.
- Check the bleed air system for leaks.
- Check the impeller for FOD.
- Check the diffuser pipes for cracking or pipes partially obstructed by remains from bird strike
- Perform a power assurance check

Please inform DETA of any results of the troubleshooting.

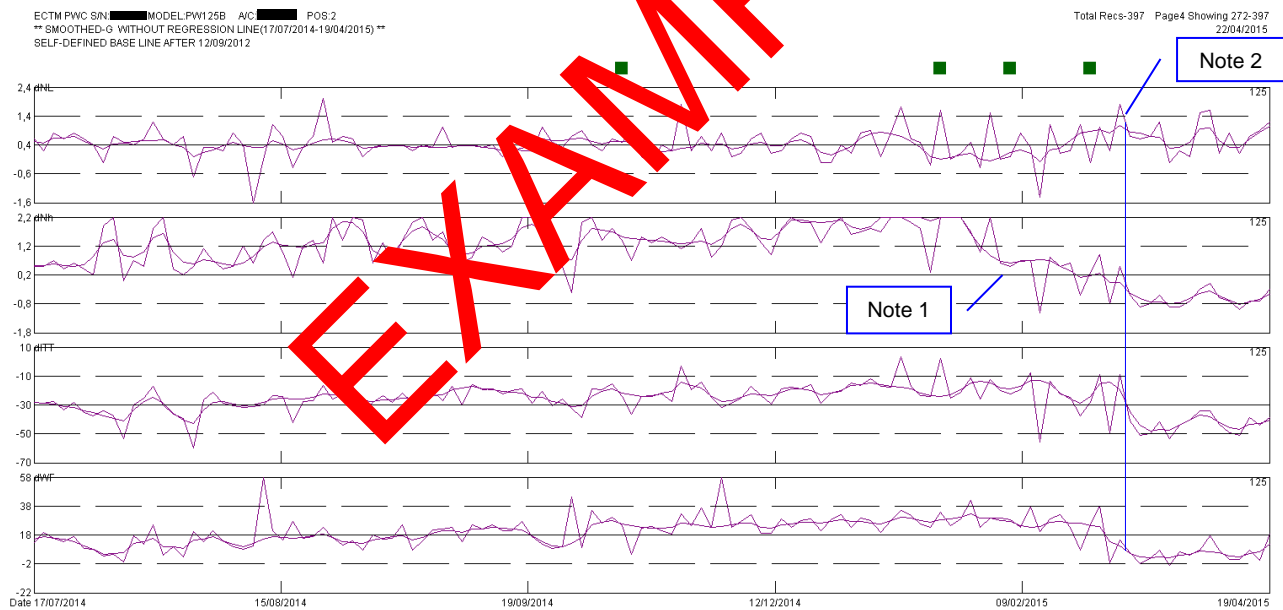
position 2
PCE-:

There was an increasing development on the NH graph for almost 6 months. Operator was informed of this in ECTM notification 124193-MAR-121114. NH is at this point almost 2% above the baseline and seems to be increasing.
Operator was in ECTM notification informed of a possible NH indication problem.

Note 1: Operator informed that NH indicator was replaced on 06/02/2015 and again on 13/02/2015 due to a defective part. NH graph seems to stabilize after this.

Note 2: Around 17/03/2015 all graphs except NL makes step changes decreasing. NH is at this point around 1% below the baseline, ITT is 15°C below the baseline and WF is 17 pounds below the baseline.
This could be maintenance performed or an engine change that we were not informed about.

Please inform if there has been any engine changes or if any maintenance has been performed around the date described in note 2 above and report back to DATA.
